CONDITIONS ASSESSMENT & PRESERVATION PLAN
of the
JASON RUSSELL HOUSE

Submitted to the Arlington Historical Society
March 2017
by:

DESIGN
ASSOCIATES

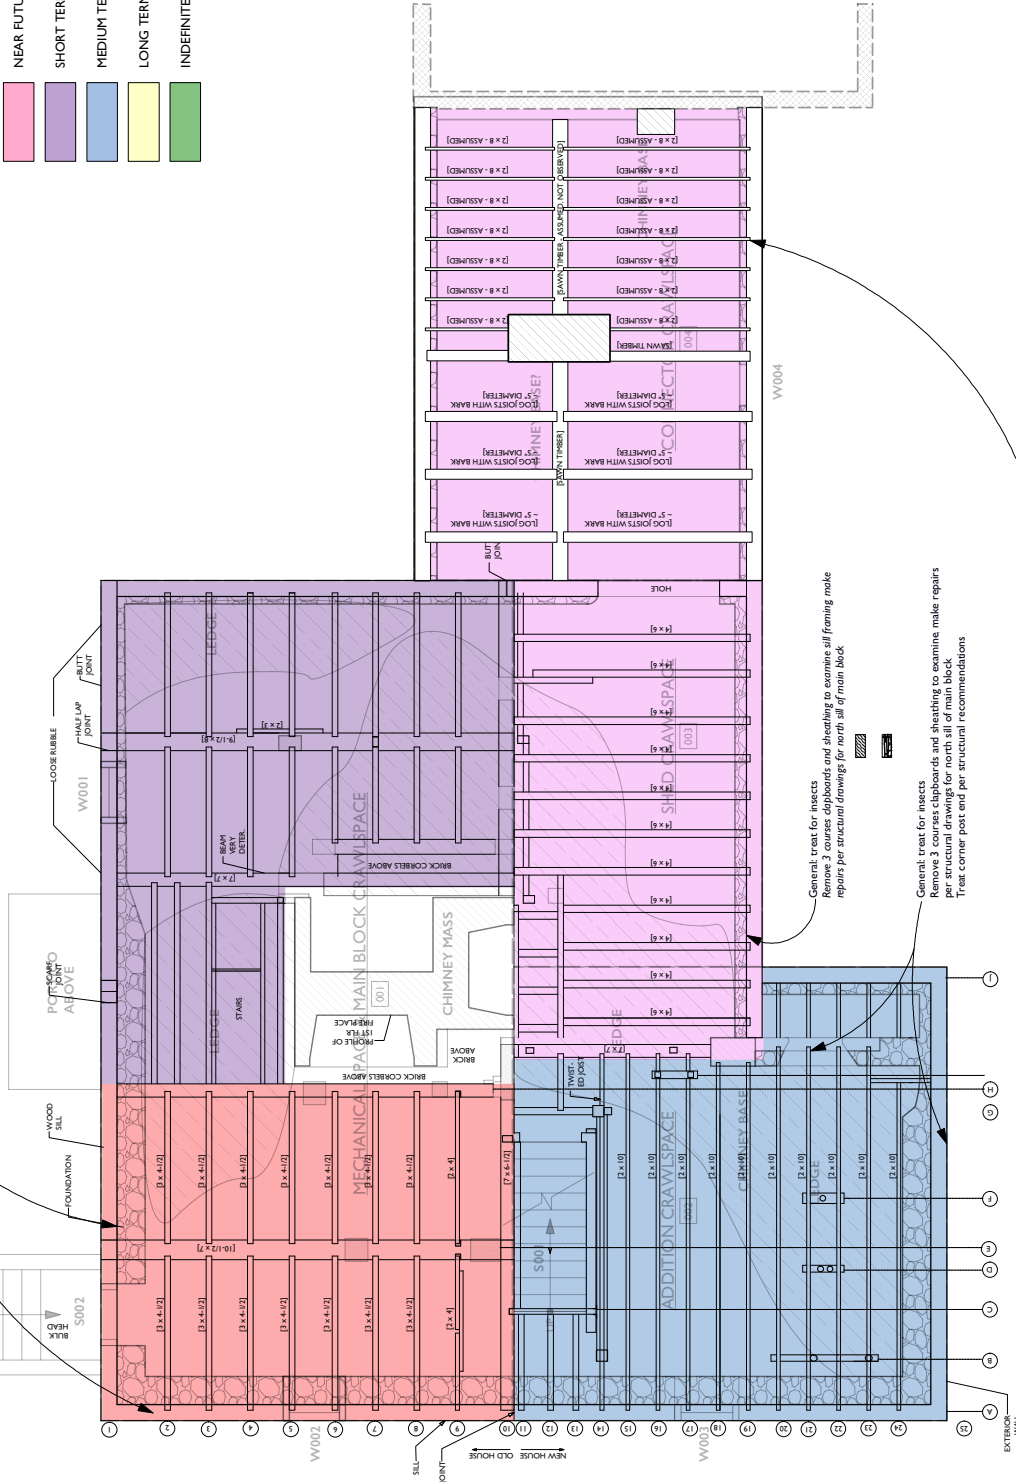
General: treat for insects
Remove 3 courses clapboards and sheathing to examine sill framing make
repairs per structural drawings for north sill of main block

General: treat for insects
Remove 3 courses clapboards and sheathing to examine make repairs
per structural drawings for north sill of main block
Treat corner post and per structural recommendations

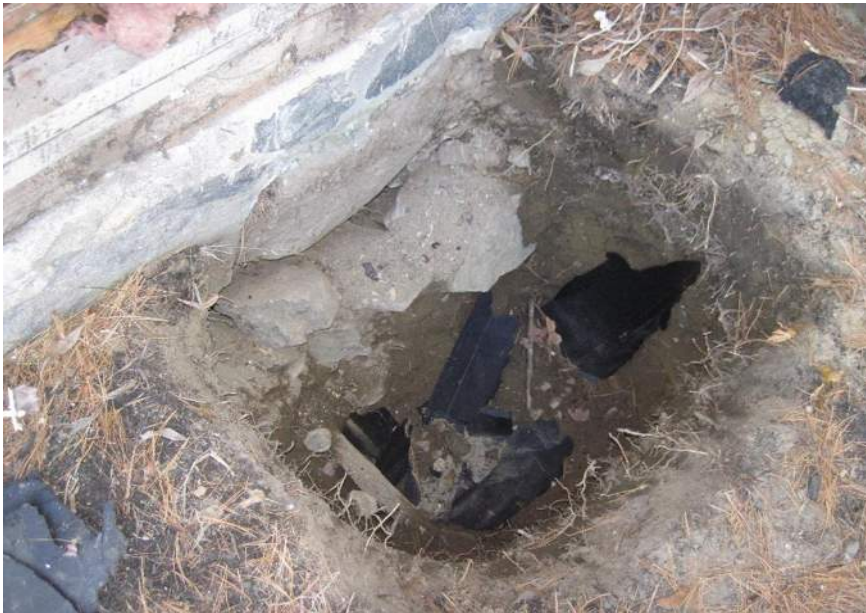
**Photo 2**

Test pit along foundation wall at north wall of original building.

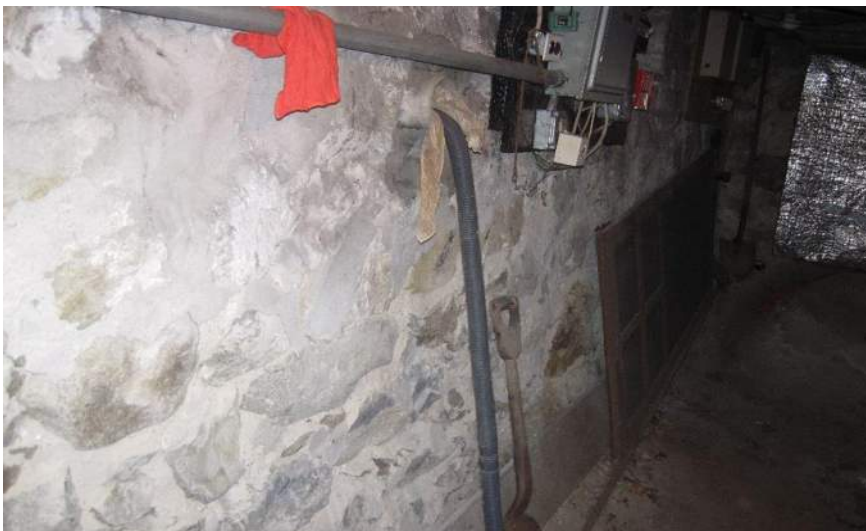
**Photo 3**

Interior of north foundation wall. Note mortar is loose and crumbling.

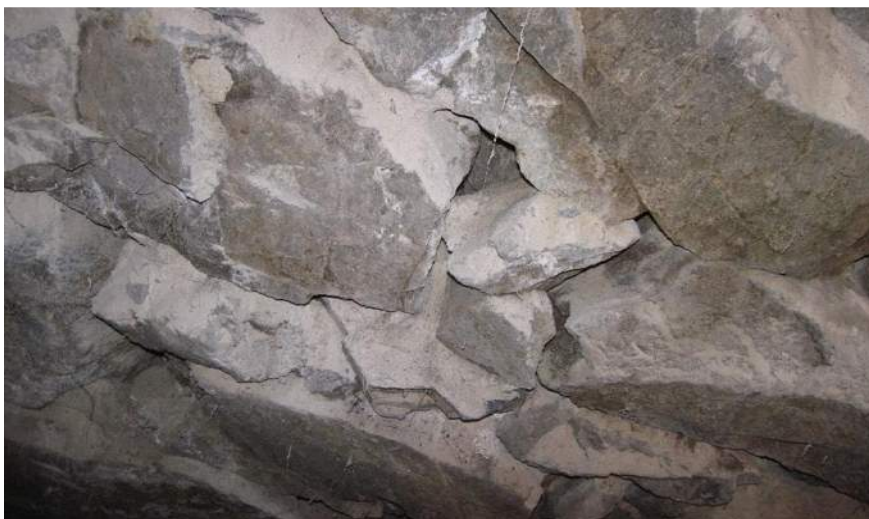
**Photo 4**

Portion of north foundation wall with loose stones.

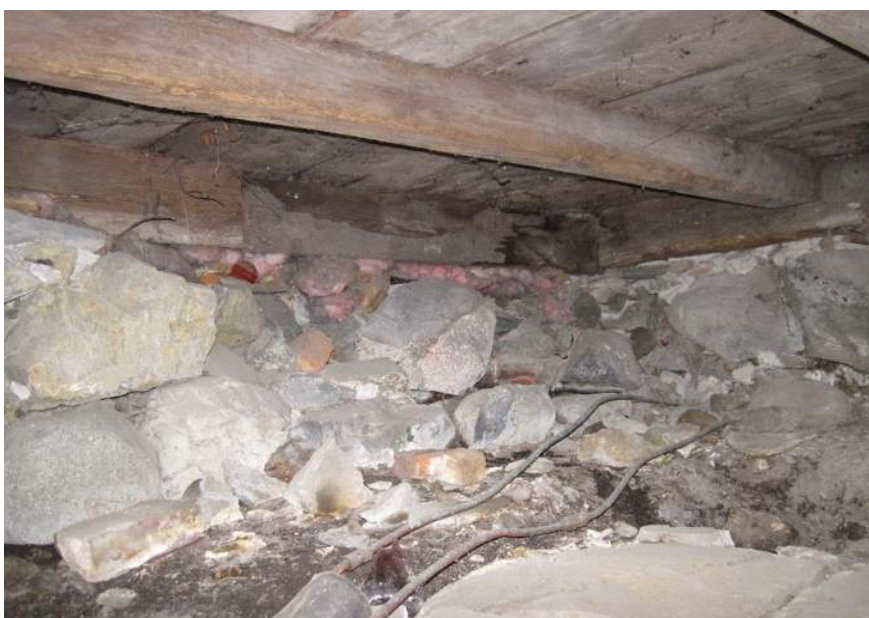
**Photo 5**

Interior of rubble foundation wall at southeast corner of building (from crawlspace).

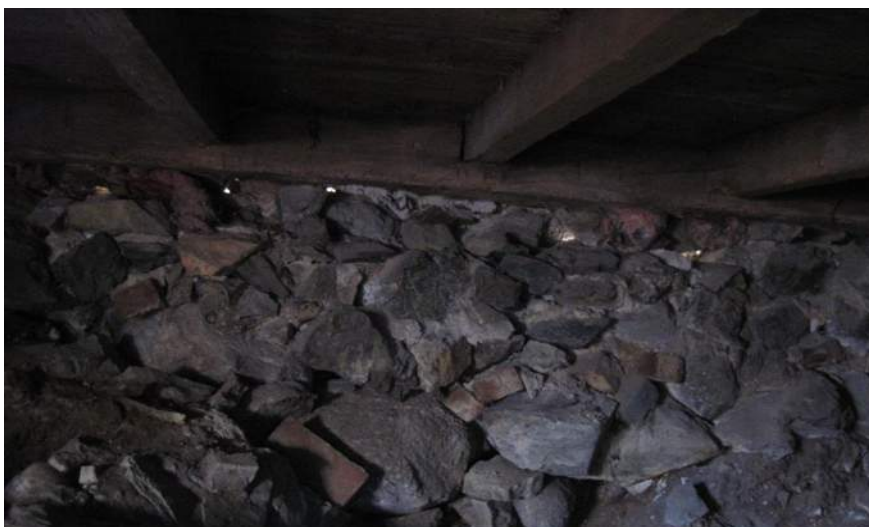
**Photo 6**

Interior of rubble foundation wall at south of building (from crawlspace).

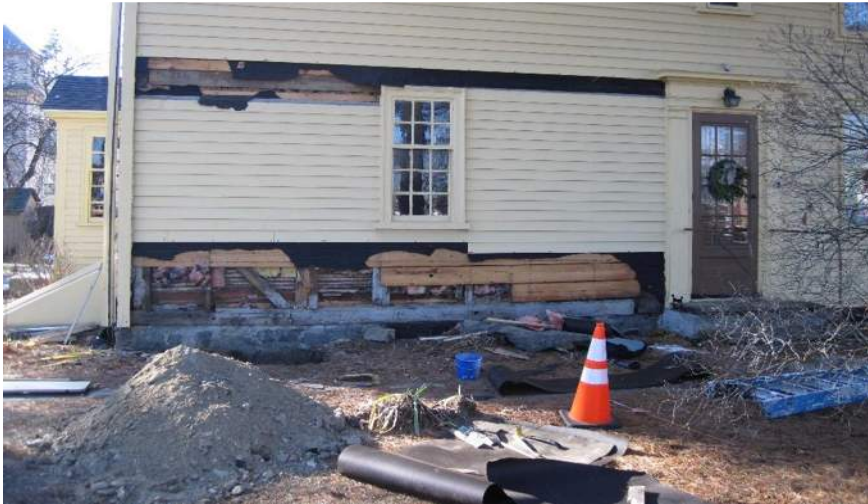
**Photo 7**

Exploratory openings at the north wall.

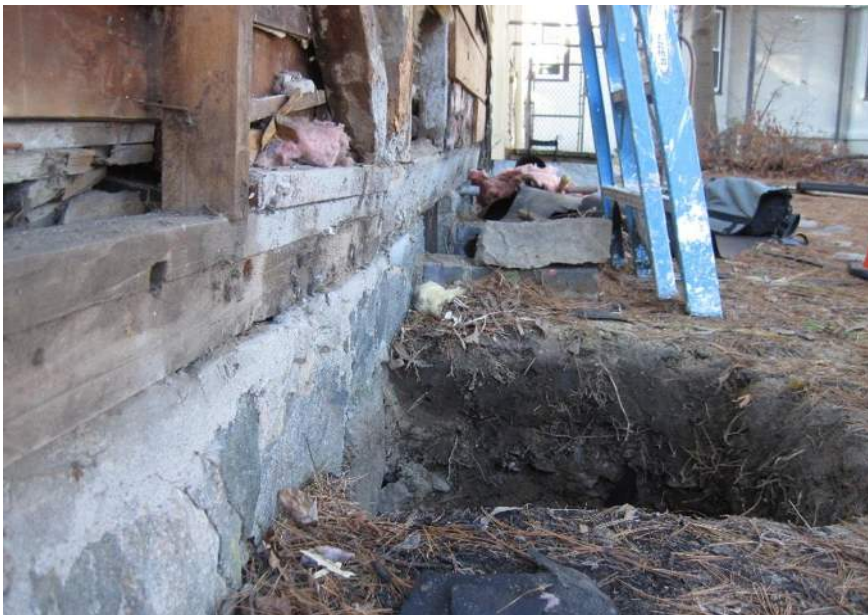
**Photo 8**

Previous sill beam repair(s) at north wall. Note rotation of sill beam. Note rubble foundation is intact, with no signs of vertical displacement.

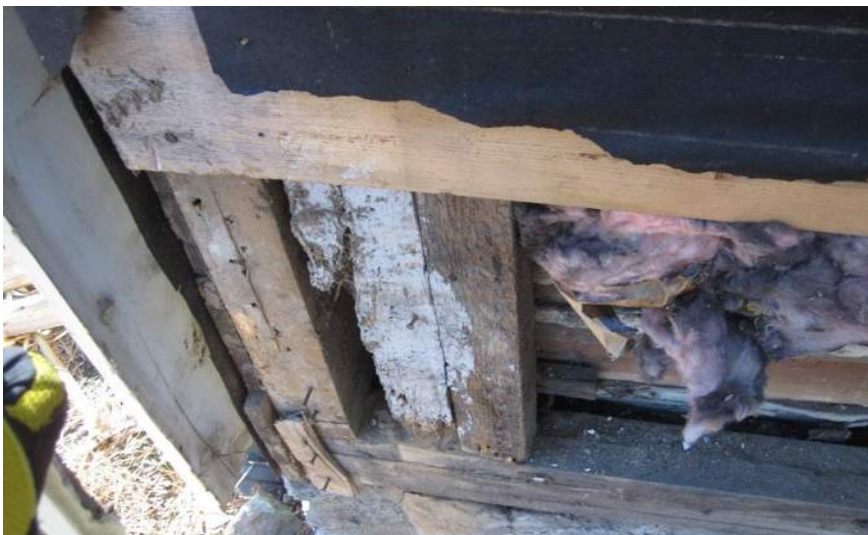
**Photo 9**

Framing at northeast corner. Note original corner post is deteriorated and was previously repaired.

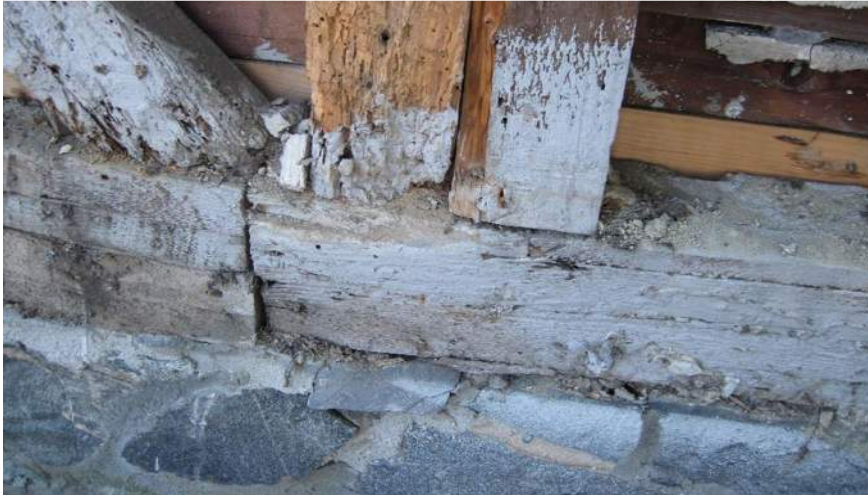
**Photo 10**

Insect damage at original wall stud and previous repair stud.

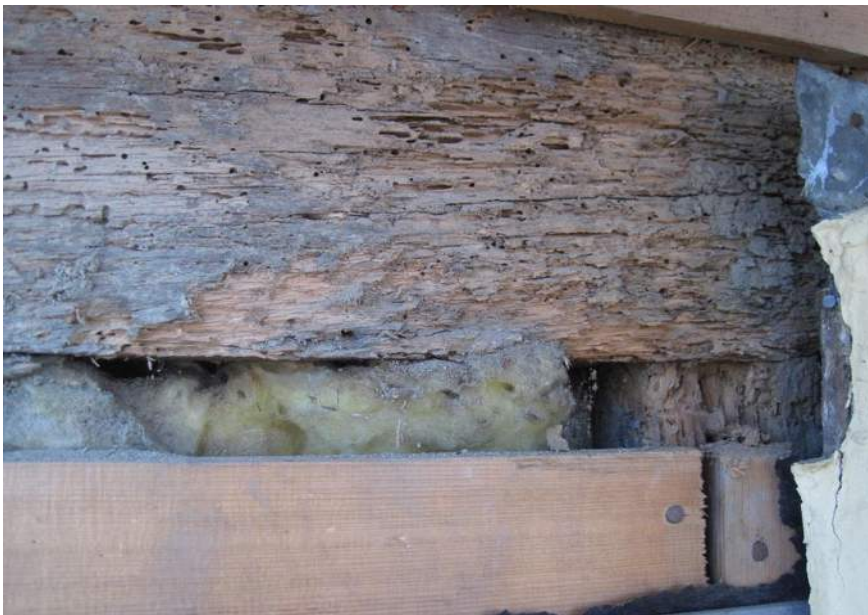
**Photo 11**

Insect damage at second floor beam, near original building corner post. Note that while there is extensive damage, the wood in neither the beam, nor the post, is crushed.

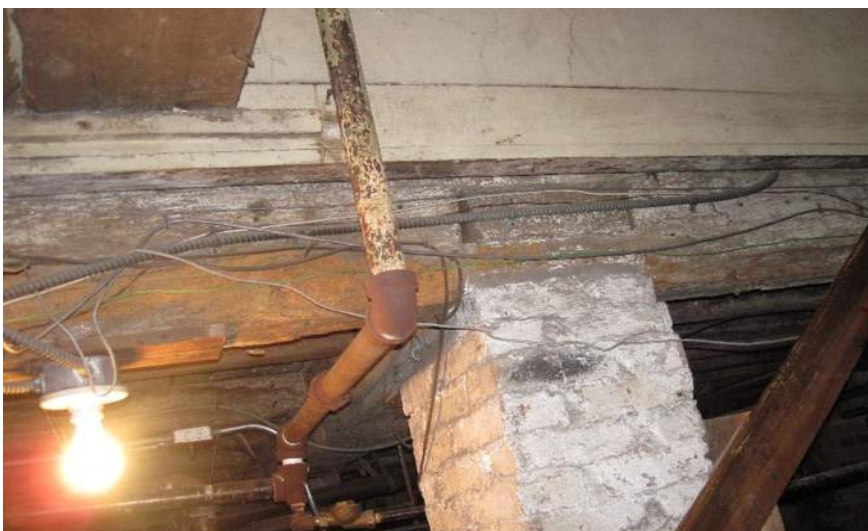
**Photo 12**

Insect damage to first floor beam in basement.

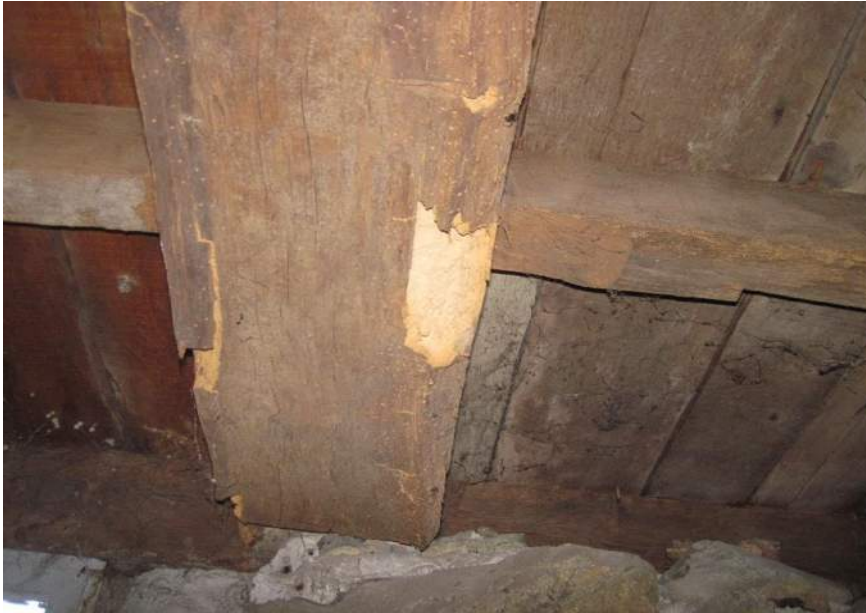
**Photo 13**

Insect damage to first floor beam at crawlspace.

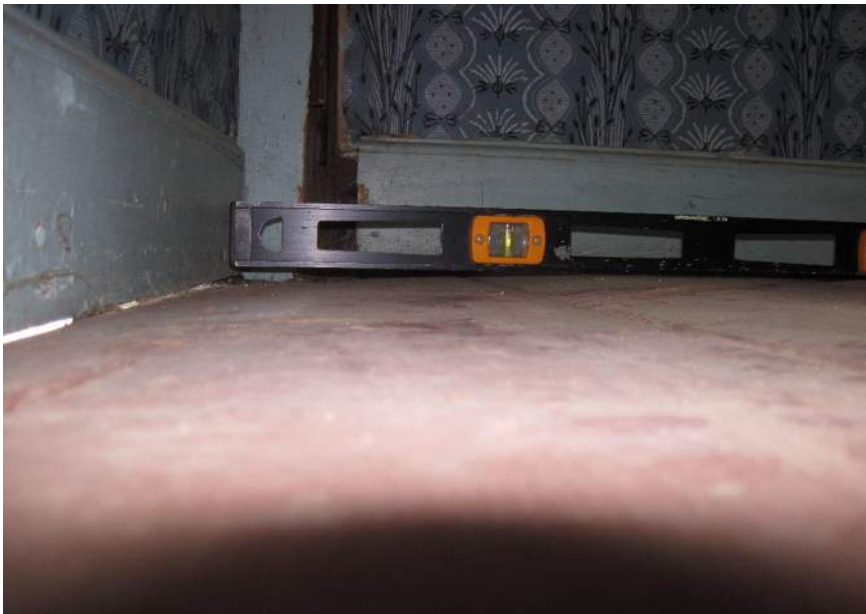
**Photo 14**

Depression in first floor along north wall. Note the light between the base trim and the floor board is from the exterior exploratory opening.

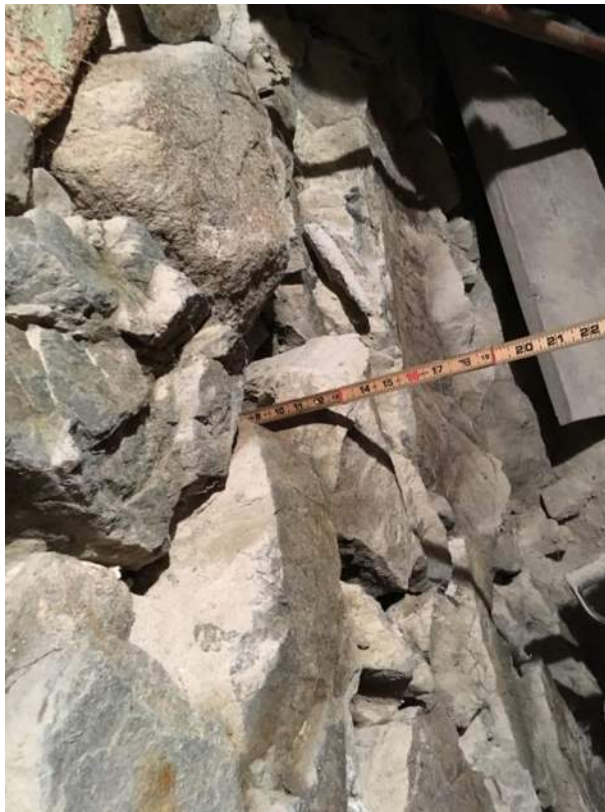
**Photo 2**

Localized, deep deterioration of the mortar joints in the foundation wall, as viewed from the cellar.

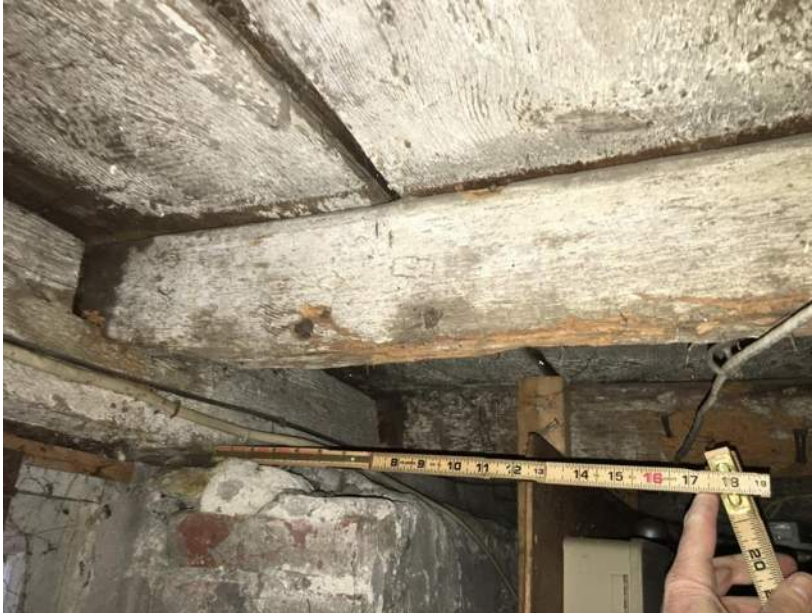
**Photo 3**

Typical wood joist to wood sill connection, with approximately 8 in. wide shelf atop foundation wall visible inboard of the sill.

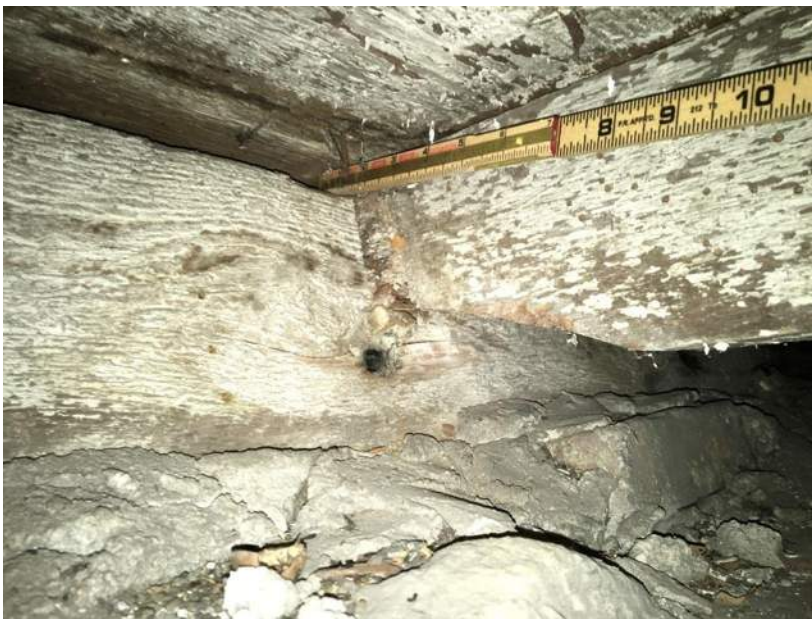
**Photo 4**

The remaining engagement of some wood joists (right) is less than 2 in. into the mortise "pocket" of the wood sill (left).

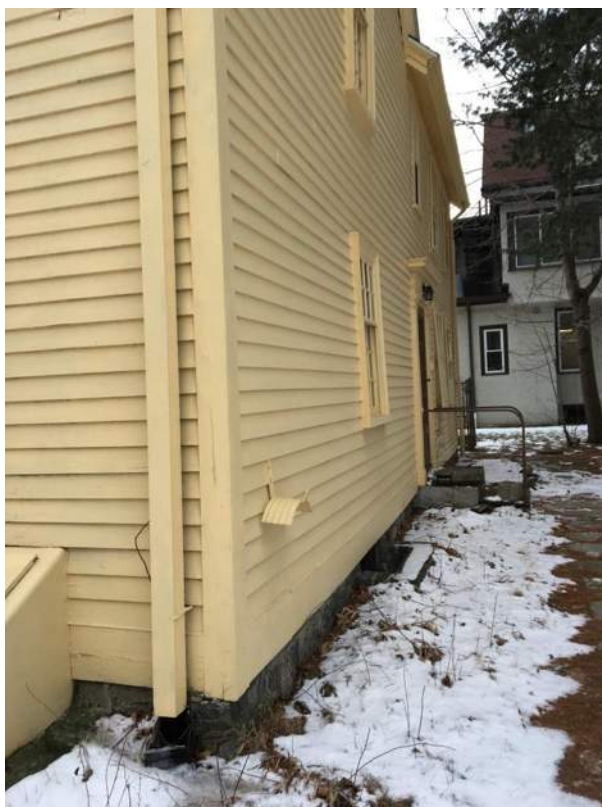
**Photo 5**

Apparent bowing of the exterior northeast wall, facing Massachusetts Avenue. The wall appears to bow outward immediately above the foundation, back in toward the second-floor line, then outward again above the second-floor line.
