CONDITIONS ASSESSMENT & PRESERVATION PLAN
of the
JASON RUSSELL HOUSE

Submitted to the Arlington Historical Society
March 2017
by:

DESIGN
ASSOCIATES

CONDITIONS ASSESSMENT

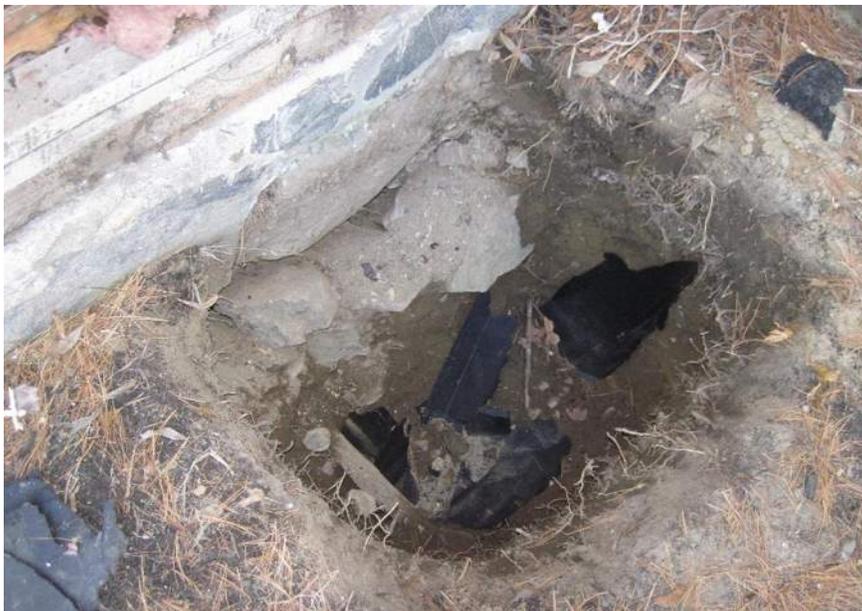
Photo 2

Test pit along foundation wall at north wall of original building.

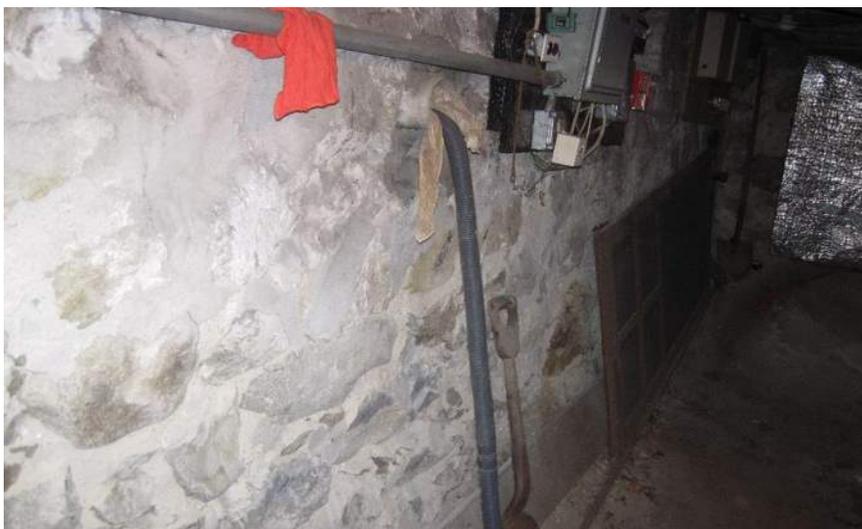
Photo 3

Interior of north foundation wall. Note mortar is loose and crumbling.

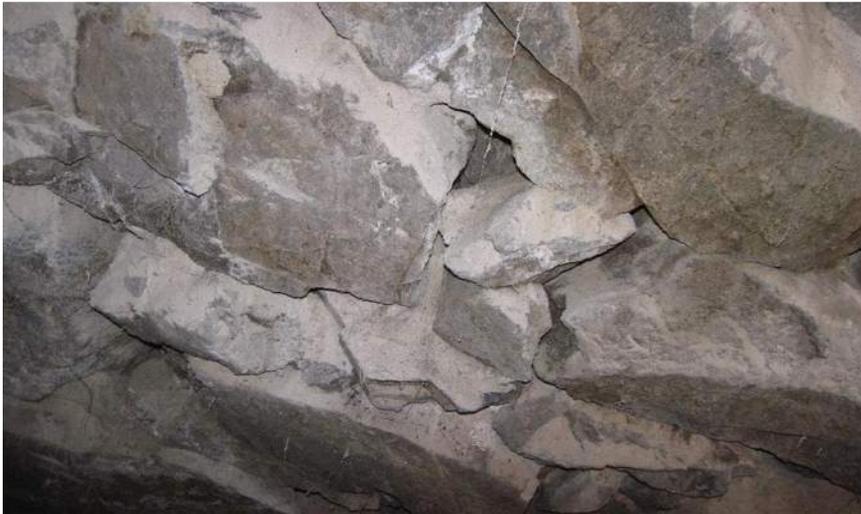
Photo 4

Portion of north foundation wall with loose stones.

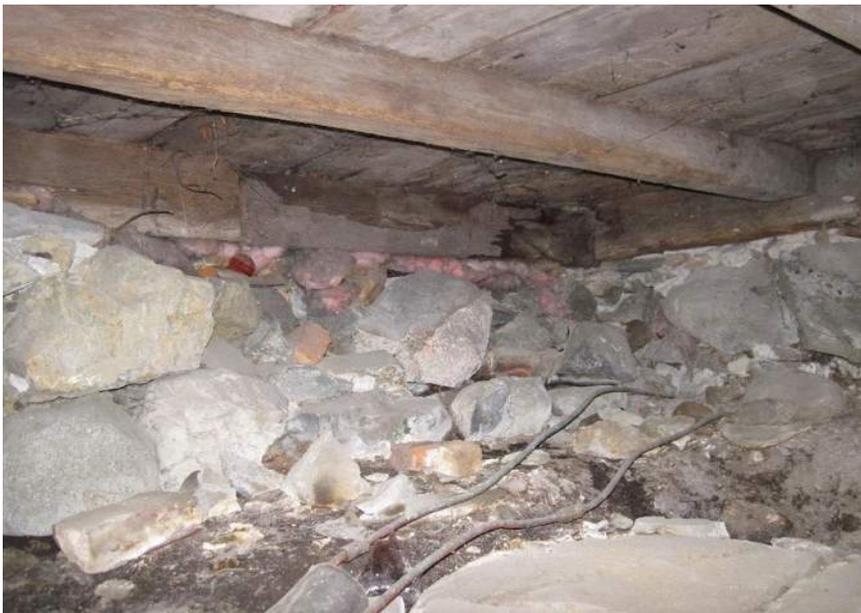
Photo 5

Interior of rubble foundation wall at southeast corner of building (from crawlspace).

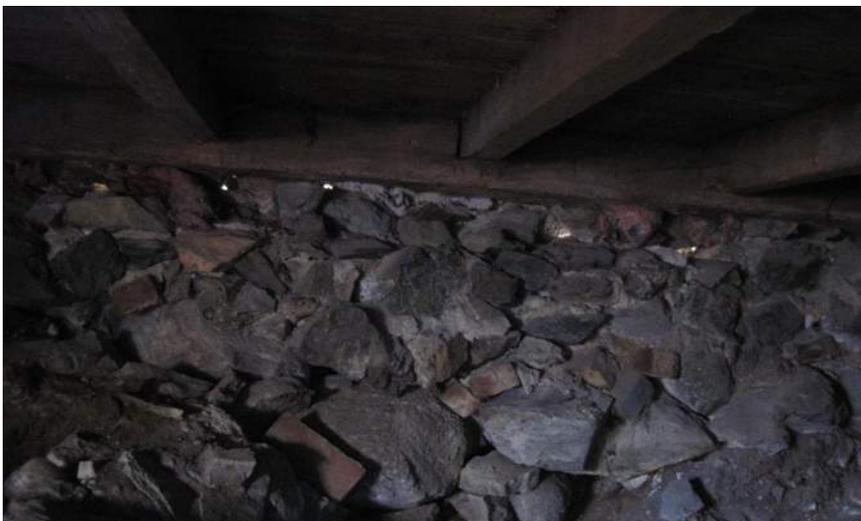
Photo 6

Interior of rubble foundation wall at south of building (from crawlspace).

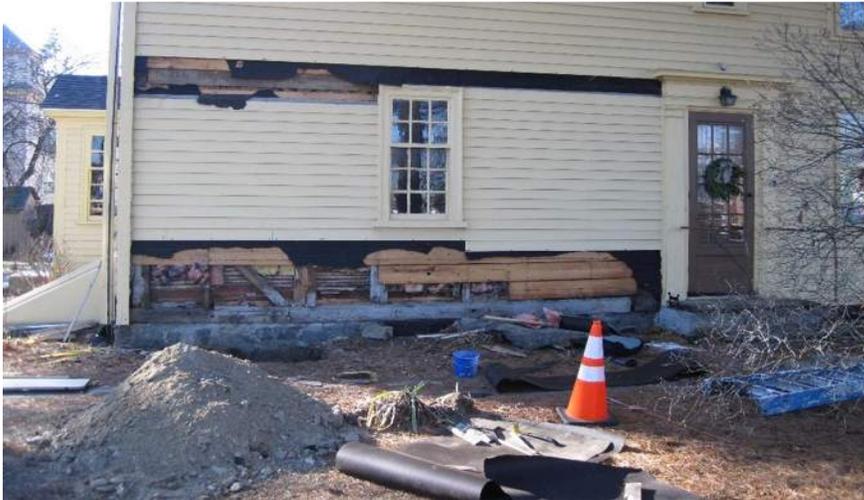
**Photo 7**

Exploratory openings at the north wall.

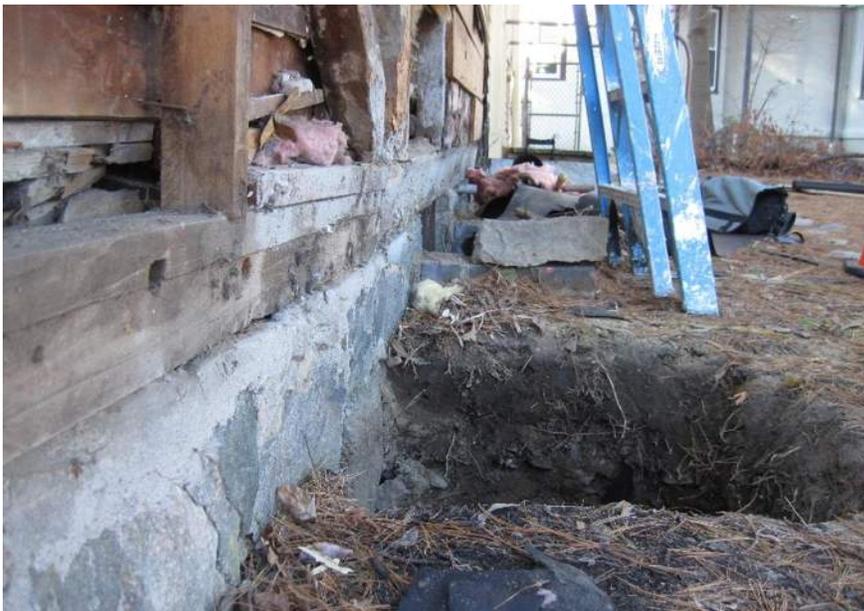
**Photo 8**

Previous sill beam repair(s) at north wall. Note rotation of sill beam. Note rubble foundation is intact, with no signs of vertical displacement.

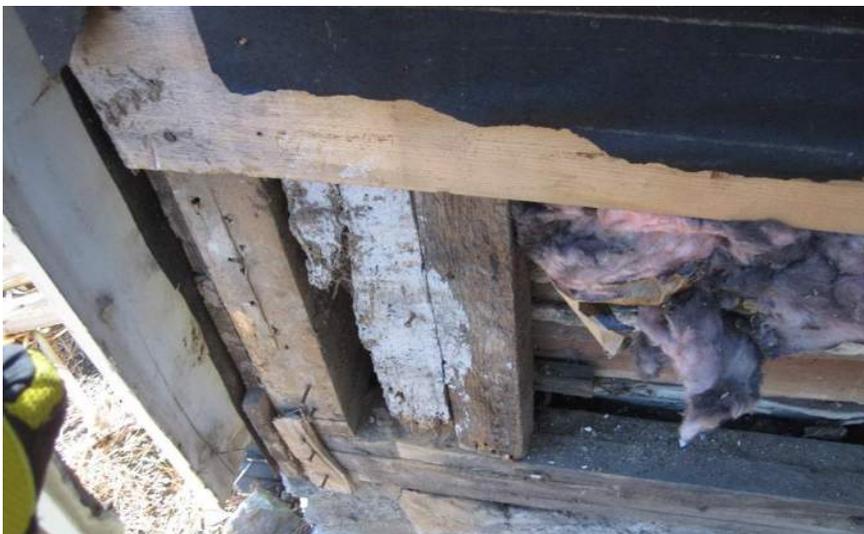
**Photo 9**

Framing at northeast corner. Note original corner post is deteriorated and was previously repaired.

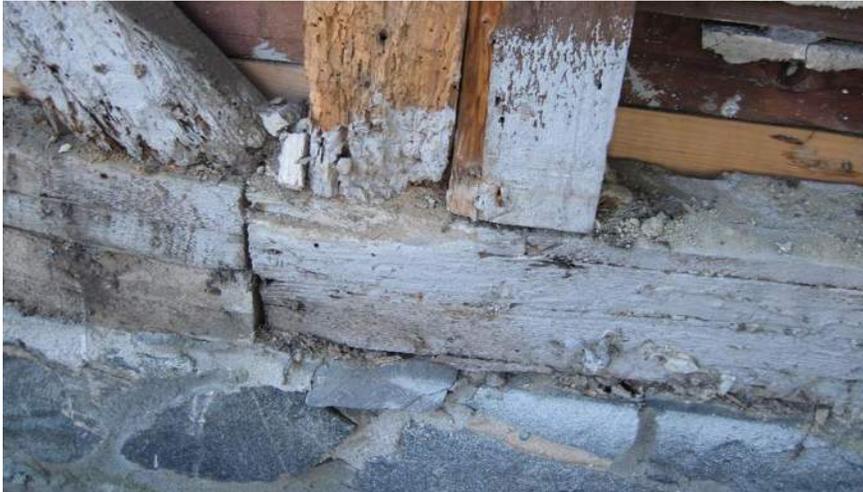
**Photo 10**

Insect damage at original wall stud and previous repair stud.

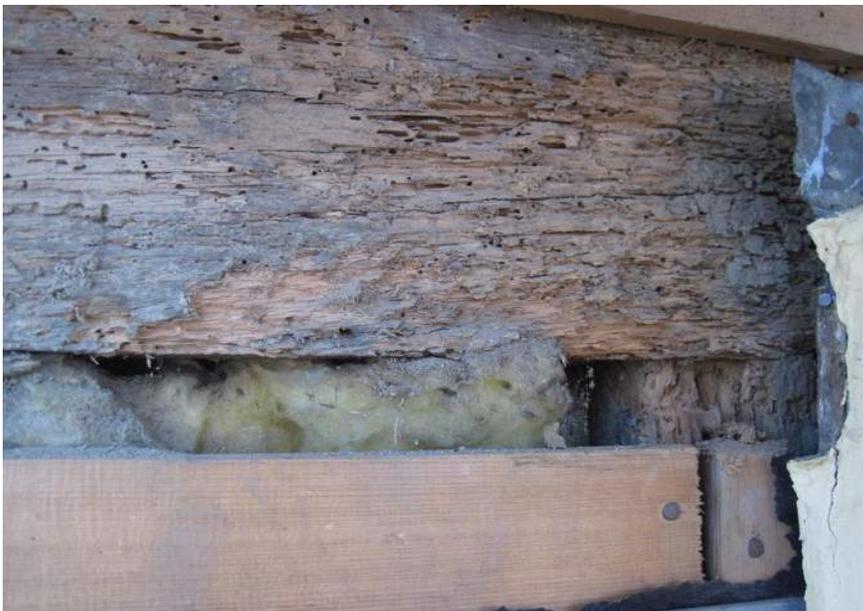
**Photo 11**

Insect damage at second floor beam, near original building corner post. Note that while there is extensive damage, the wood in neither the beam, nor the post, is crushed.

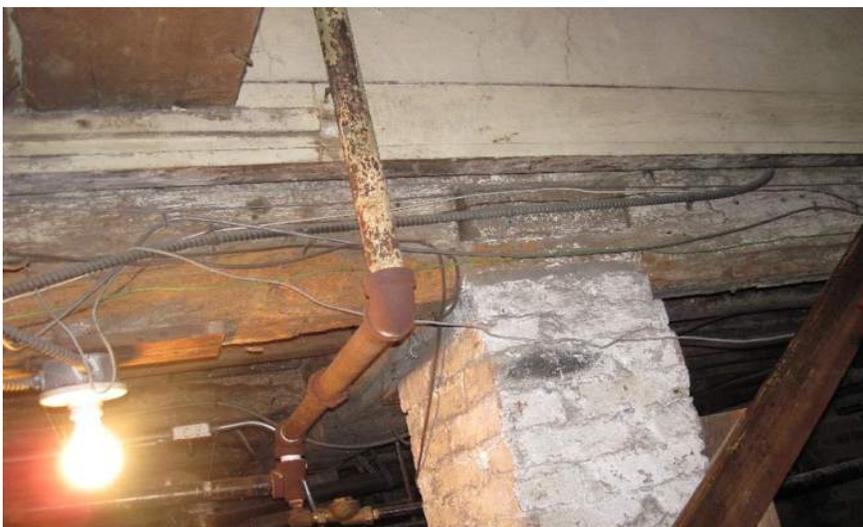
**Photo 12**

Insect damage to first floor beam in basement.

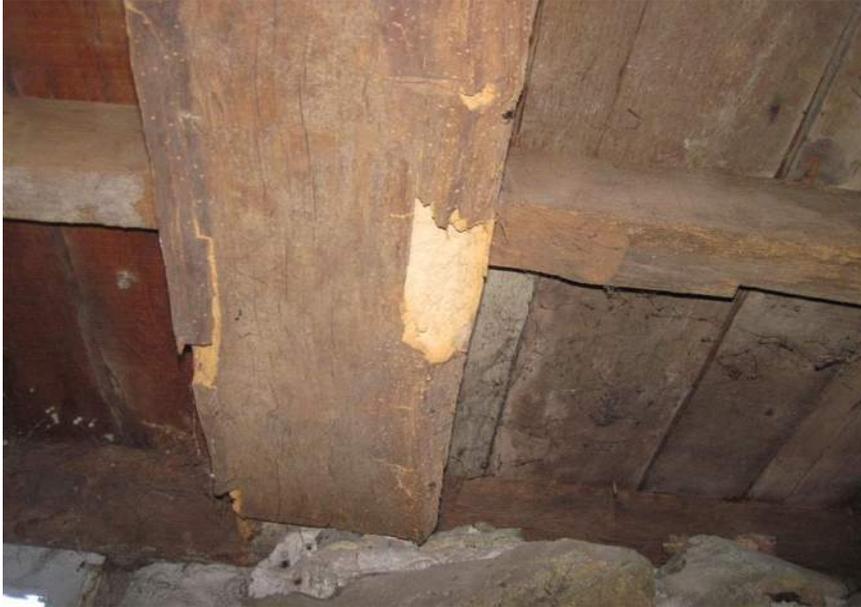
**Photo 13**

Insect damage to first floor beam at crawlspace.

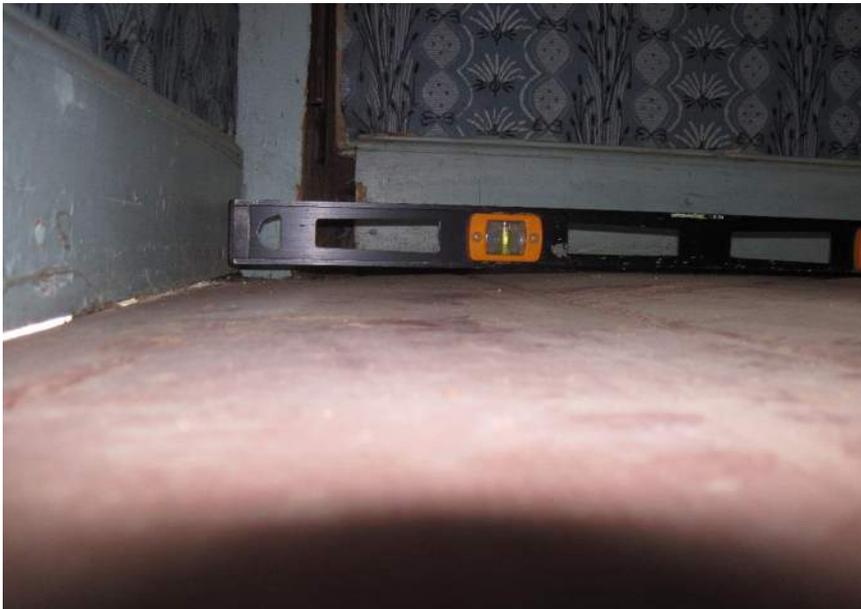
**Photo 14**

Depression in first floor along north wall. Note the light between the base trim and the floor board is from the exterior exploratory opening.

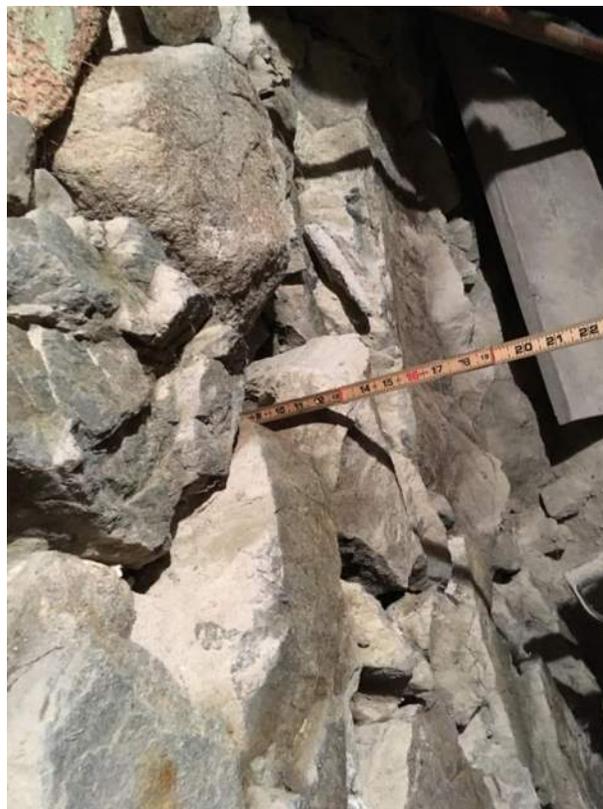
Photo 2

Localized, deep deterioration of the mortar joints in the foundation wall, as viewed from the cellar.

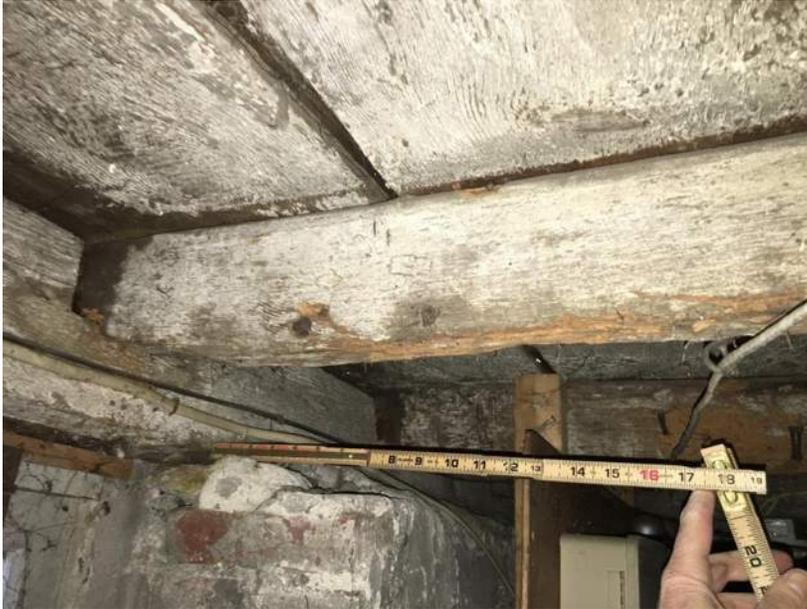
**Photo 3**

Typical wood joist to wood sill connection, with approximately 8 in. wide shelf atop foundation wall visible inboard of the sill.

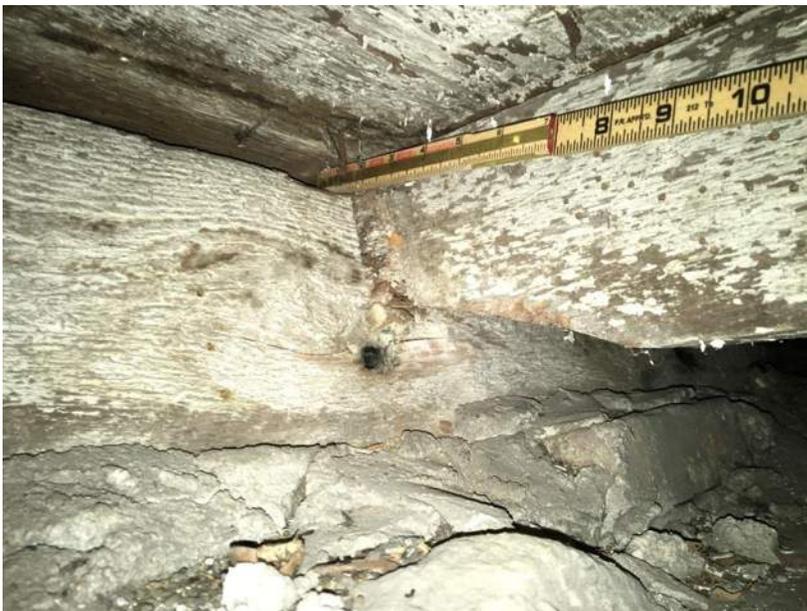
**Photo 4**

The remaining engagement of some wood joists (right) is less than 2 in. into the mortise “pocket” of the wood sill (left).

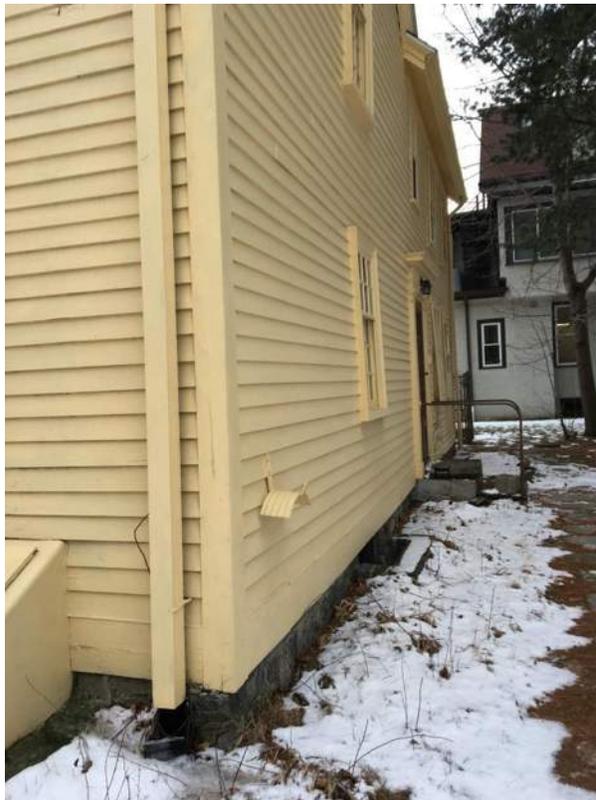
Photo 5

Apparent bowing of the exterior northeast wall, facing Massachusetts Avenue. The wall appears to bow outward immediately above the foundation, back in toward the second-floor line, then outward again above the second-floor line.
