CONDITIONS ASSESSMENT & PRESERVATION PLAN
of the
JASON RUSSELL HOUSE

Submitted to the Arlington Historical Society
March 2017
by:

DESIGN
ASSOCIATES

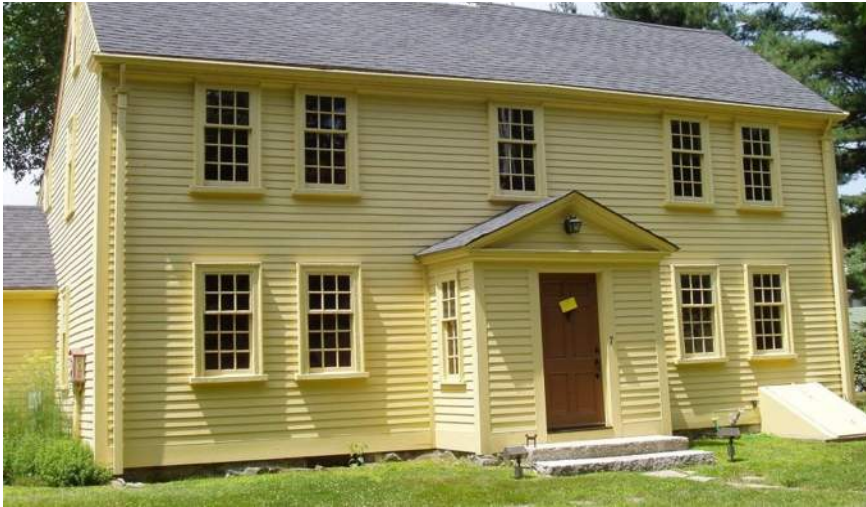
**Photo 1**

- The Jason Russell House (Photo 1) is listed on the National Register of Historic Places, and is a contributing property to the Arlington Center Historic District. The house was constructed circa 1740, for and by the farmer, Jason Russell.

Exterior view of the Jason Russell House.

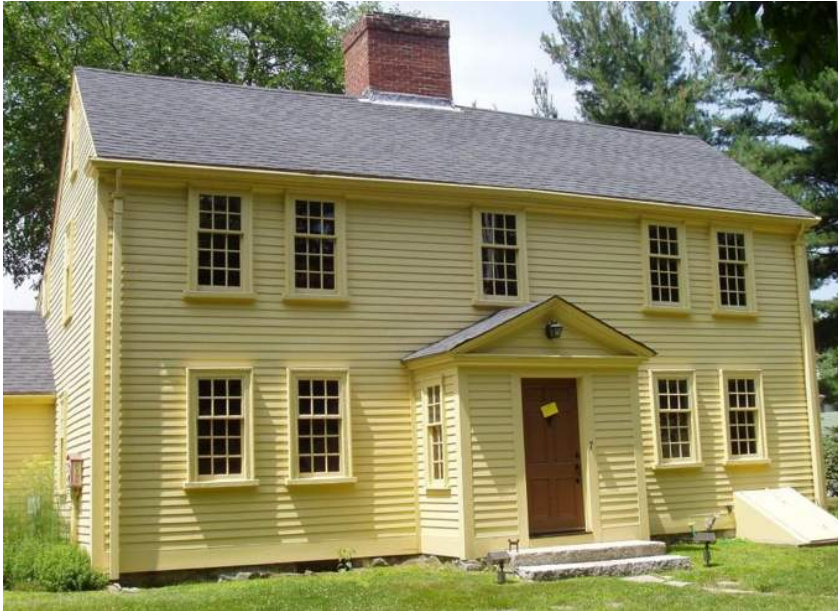
**Photo 1**

- The Jason Russell (Photo 1) is listed on the National Register of Historic Places, and is a contributing property to the Arlington Center Historic District. The house was constructed circa 1740, for and by the farmer Jason Russell.

Exterior view of the Jason Russell House.
